FINAL REPORT  
DELAWARE RIVER BASIN  
LANDSAT DATA COLLECTION SYSTEM  
EXPERIMENT

THE DELAWARE RIVER BASIN  
LANDSAT-DATA COLLECTION SYSTEM  
EXPERIMENT\*

by  
Richard W. Paulson

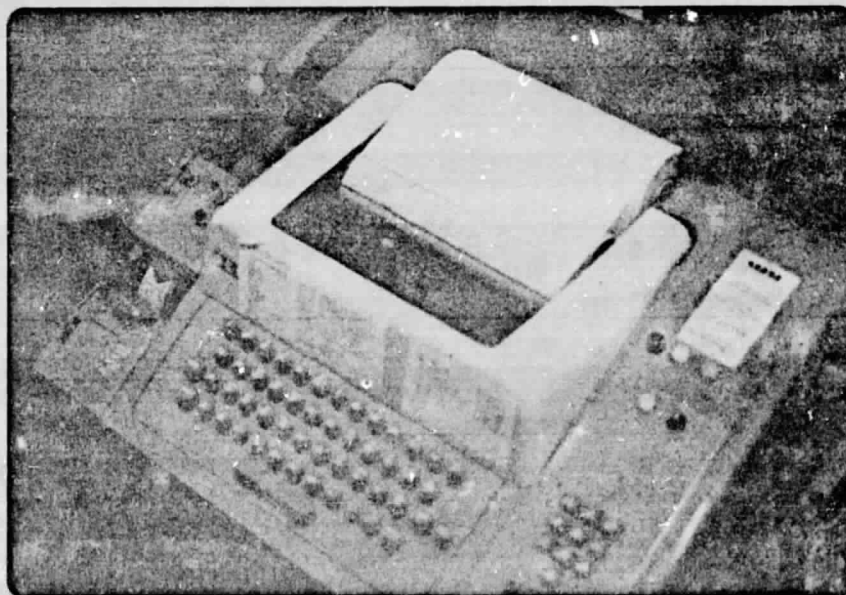
Figure 8: ASR-33 Teletypewriter Terminal

The Geological Survey's Harrisburg, Pa. office has two computer terminals that were used for the ERTS experiment. One is a high-speed batch terminal, a Data 100 model 70-2 shown in figure 7, that uses a 4,800 bits per second (baud) Binary Synchronous Communications (BSC) line for telecommunications. This terminal has a card reader, card punch, and line printer. The second terminal, an ASR-33 teletypewriter terminal that uses a 110 baud asynchronous line is shown in figure 8. This conventional teletypewriter was easily configured to be a remote computer terminal. It produces page copies and can punch or read an 8-level ASCII-encoded paper tape. These two terminals are typical of the classes of terminals found in WRD offices that provide access to a powerful computing system and WRD data files.

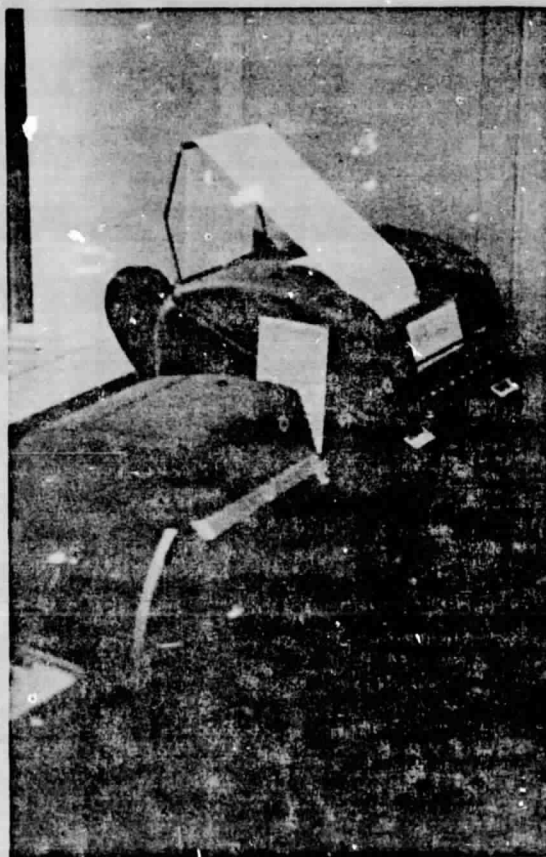
Figure 9: NASA Supplied Teletype

Data from LANDSAT DCS were provided by a dedicated-line teletype shown in figure 9. This teletype provided line copy as shown in figure 10, and a 5 channel paper tape. Within about 30-45 minutes after the completion of LANDSAT data-relay pass over North America, DCS data from the Delaware River basin test site were transmitted from the Goddard Space Flight Center's LANDSAT Operations Control Center to Harrisburg. Data on the 5-channel paper tape were punched simultaneously with the listing of the data on the teletypewriter printer.
